west virginia department of environmental remediation
Office of Environmental Remediation

VRP Project #: **15017**
Brownfield Site: Yes ☐ No ☒
Report Date: **3-9-16**
Page **1** of **6**

OFFICE OF ENVIRONMENTAL REMEDIATION
VOLUNTARY REMEDIATION PROJECT
SITE VISIT/INSPECTION REPORT

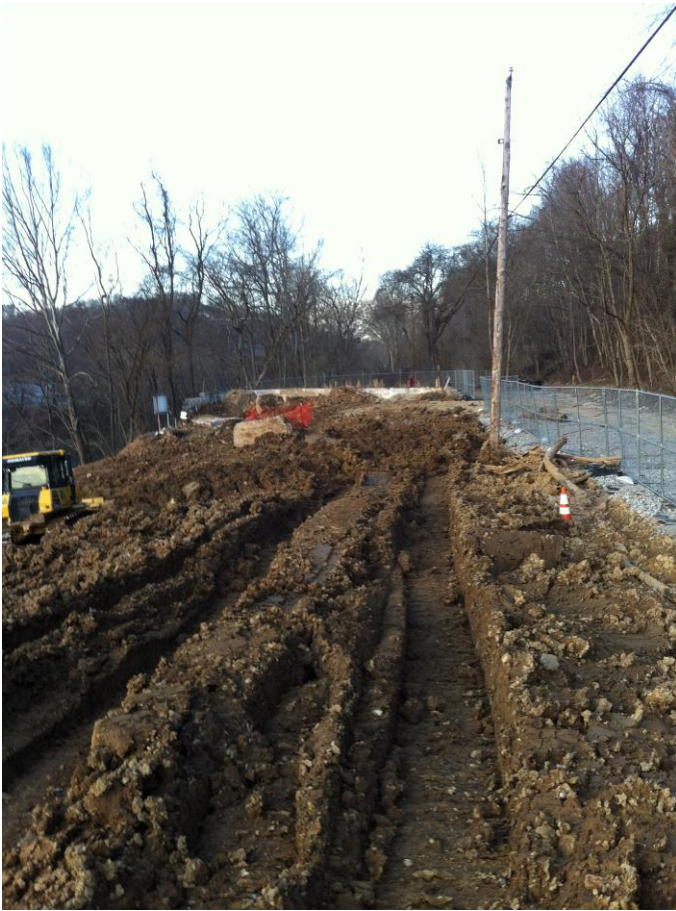
Started trucking clay soil in today for capping material - material is being purchased and delivered from a location just off the Tupper's Creek exit of I-77. Six loads were delivered and staged on site before a dozer hit an unmarked gas line. Additional trucks were called off so that the staged clay would not be in the way of site work and gas line repair. Additional clay will be brought in tomorrow.

1. Dozer having difficulty moving clay capping material
2. Area of gas line leak - dozer was pushing large boulder which struck the gas line valve.

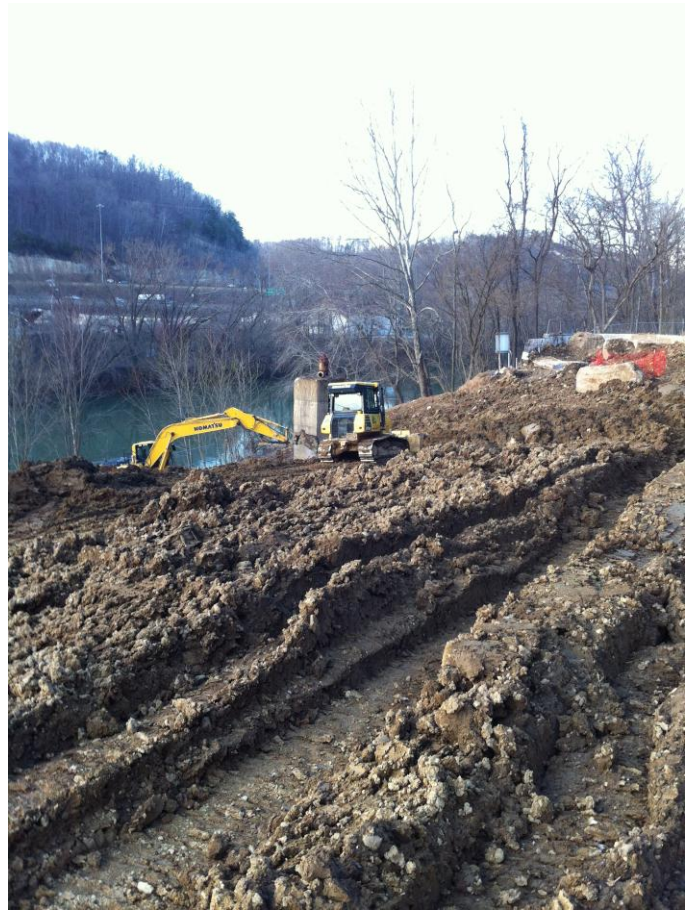
Grading of slope area continued today along with initiating the spreading of clay capping material in Area 3 - slope is looking good. Discussions continued about how to address the toe of the slope where the excavator got stuck yesterday.

3. Dozer grading slope which now reaches into Area 3.
4. Dozer positioning boulder to aid in slope stability.
5. Heavy equipment working in Areas 3 & 4.
6. View of modified slope - looking southwest.
7. Dozer spreading clay capping material in upper portion of slope in Area 3.
8. Close-up of area where gas line valve was damaged.
9. Excess material from slope grading was spread in Area 1A.
10. View of slope looking northeast from collection trench area.
11. View of slope looking southeast from collection trench area.
12. Excavator working on slope - looking south.
13. Trench area at toe of slope.
14. View from lower level looking northeast towards slope area.
15. Repair crew working to stop gas leak.

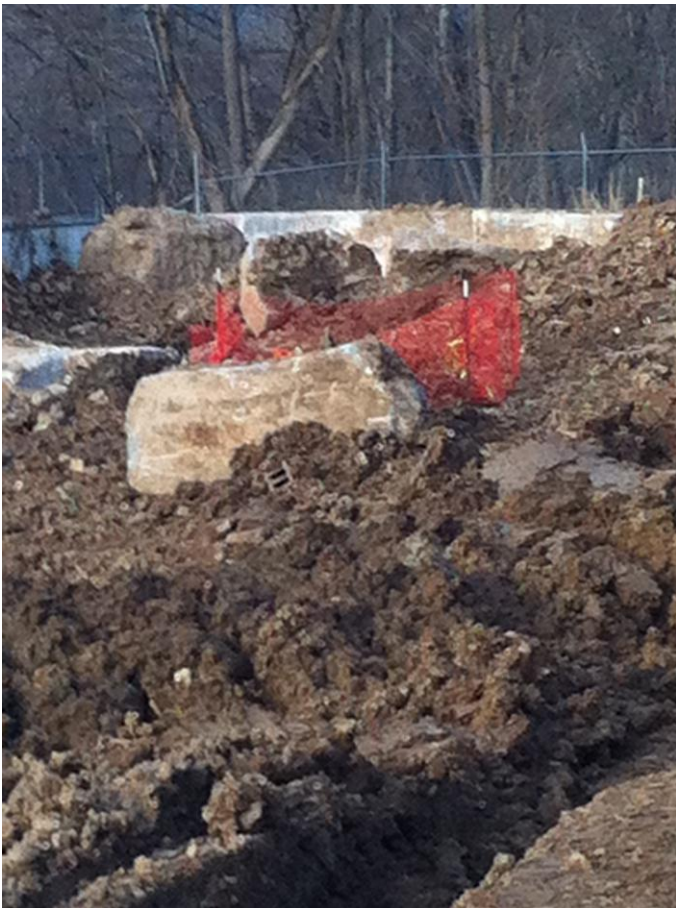
2.

Dozer hit the top of an unmarked gas live valve and caused a leak in the valve. Gas company came out and stopped the leak but needs to order parts to repair valve - likely won't be fixed until next week at the earliest. Utility marking for the 10" high pressure gas lines was approximately 15' off of actual location. Contact with Mountaineer Gas Co. is Bob Winans.
